DEPARTMENT OF TRANSPORTATION**DIVISION OF ENGINEERING SERVICES**

Quality Assurance and Source Inspection

Contract #: 04-0120F4Cty: SF/ALA Rte: 80 PM: 13.2/13.9File #: 1.28**WELDING INSPECTION REPORT****Resident Engineer:** Casey, William**Address:** 333 Burma Road**City:** Oakland, CA 94607**Report No:** WIR-027222**Date Inspected:** 17-Feb-2012**Project Name:** SAS Superstructure**OSM Arrival Time:** 700**Prime Contractor:** American Bridge/Fluor Enterprises, a JV**OSM Departure Time:** 1730**Contractor:** American Bridge/Fluor Enterprises, a JV**Location:** Job Site**CWI Name:** Salvador Merino**CWI Present:** Yes No**Inspected CWI report:** Yes No N/A**Rod Oven in Use:** Yes No N/A**Electrode to specification:** Yes No N/A**Weld Procedures Followed:** Yes No N/A**Qualified Welders:** Yes No N/A**Verified Joint Fit-up:** Yes No N/A**Approved Drawings:** Yes No N/A**Approved WPS:** Yes No N/A**Delayed / Cancelled:** Yes No N/A**Bridge No:** 34-0006**Component:** OBG**Summary of Items Observed:**

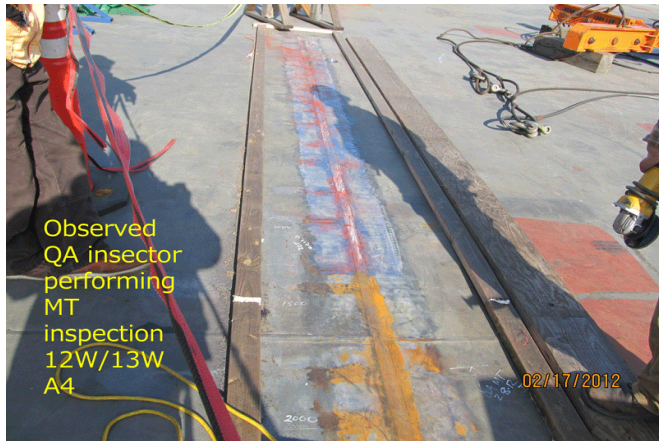
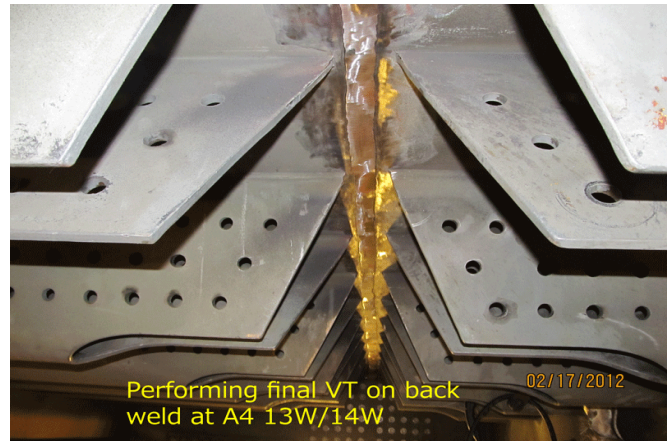
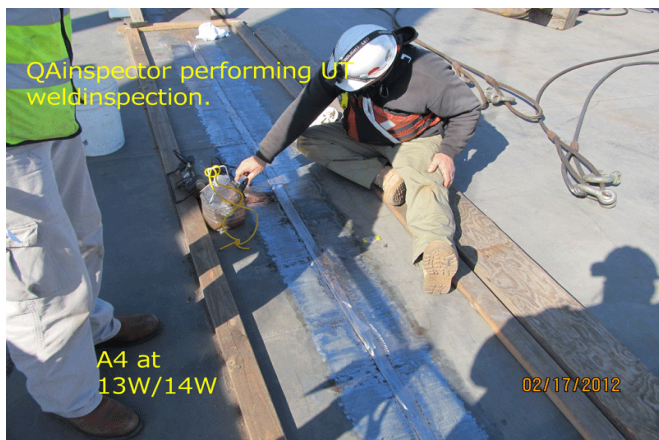
This QA observed, at random intervals, ABF/JV qualified welder Mike Jimenez #4671 performing Shielded Metal Arc Welding (SMAW) with 1/8" diameter E7018H4R electrode and implementing Caltrans approved Welding Procedure Specification (WPS) ABF-WPS-D15-1050A-CU. This was a Complete Joint Penetration (CJP) weld on a 14mm plate insert at the "A" deck to close the lifting lug deck penetration holes. This work was located at 13W PP119.5 W3 1 was performed in the flat position from the topside of the "A" deck plate. During welding, ABF Quality Control (QC) Salvador Merino was noted monitoring the welding parameters. Welding parameters were recorded. Also verified that CU backup strip was secured from top and under deck.

This QA observed, at random intervals, ABF/JV qualified welder Richard Garcia #5892 performing Flux Cored Arc Welding (FCAW) with 1.6mm diameter E71T-1M electrode and implementing Caltrans approved Welding Procedure Specification (WPS) ABF-WPS-D15-1012-3. This was a Complete Joint Penetration (CJP) weld connecting vertical stiffener plates to stiffener plate. This work was located at West line connection joint 13W to 14W LS 5.

Weld inspection was observed at 13W/14W weld # E2.

This QA inspector observed ABF QC personnel performing MT weld inspection in accordance with section 6 of AWS D1.5. All work was being performed by certified personnel performing MT testing to level II requirements. Weld inspection was observed at 13W/14W weld # A4.
